# Deepwater Slough Restoration Monitoring: Channel Cross-section Comparisons, 2000 - 2006

W. Gregory Hood  
Skagit River System Cooperative  
LaConner, Washington

10 May 2006

Prepared for US Army Corps of Engineers, Seattle District

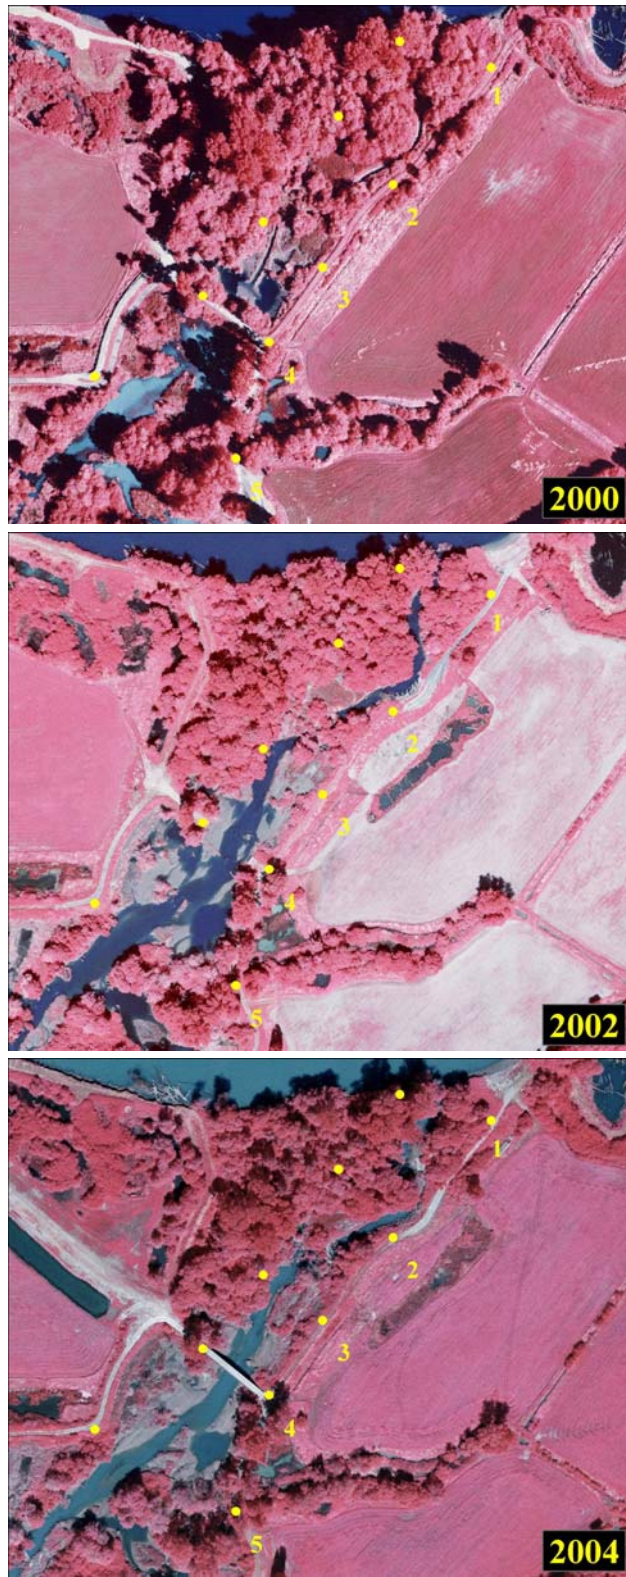
Planform changes along the Deepwater Slough distributary have occurred almost exclusively at the upstream end of the channel (Fig. 2). Downstream areas, in contrast, have experienced minor planform change. Upstream planform changes from 2002 to 2004 are difficult to discern precisely because forest canopy obscures much of the channel bank and channel. A canopy gap exposes some river water to aerial view and this gap has been widening from 2002 to 2004, indicating channel bank erosion and recruitment of riparian trees to LWD (large woody debris). The 2004 aerial photos and field observations indicate that much of this new LWD lies within the channel. The most significant geomorphic change occurred following the October 2003 flood, which carved a second channel (an avulsion) that diverges from Deepwater slough approximately 70m from its inlet and rejoins the channel approximately 105m downstream. The downstream portion of this new channel is revealed in the air photos by a gap in the forest canopy between transects 2 and 3.

Additionally, Freshwater Slough (the principal distributary of the South Fork Skagit River) is eroding near the inlet of Deepwater Slough. The river bank retreated by approximately 3m between 2002 and 2004. Likewise there has been significant bank erosion approximately 200m downstream along Freshwater Slough, that is threatening the integrity of the WDFW dikes protecting property currently managed for agricultural field-based waterfowl hunting. (WDFW has built set-back dikes in anticipation of dike failure.) Both of these erosional areas are located on the same cut-bank of a large bend in Freshwater Slough. The location of the Deepwater Slough inlet on a rapidly eroding cut-bank suggests that this inlet is exposed to high erosive energies and that further channel erosion is likely along both Freshwater and Deepwater Sloughs.

Figure 2. Planform comparisons of the dynamic upstream portion of Deepwater Slough. Cross-section transect start and end points are denoted by numbers and dots respectively.

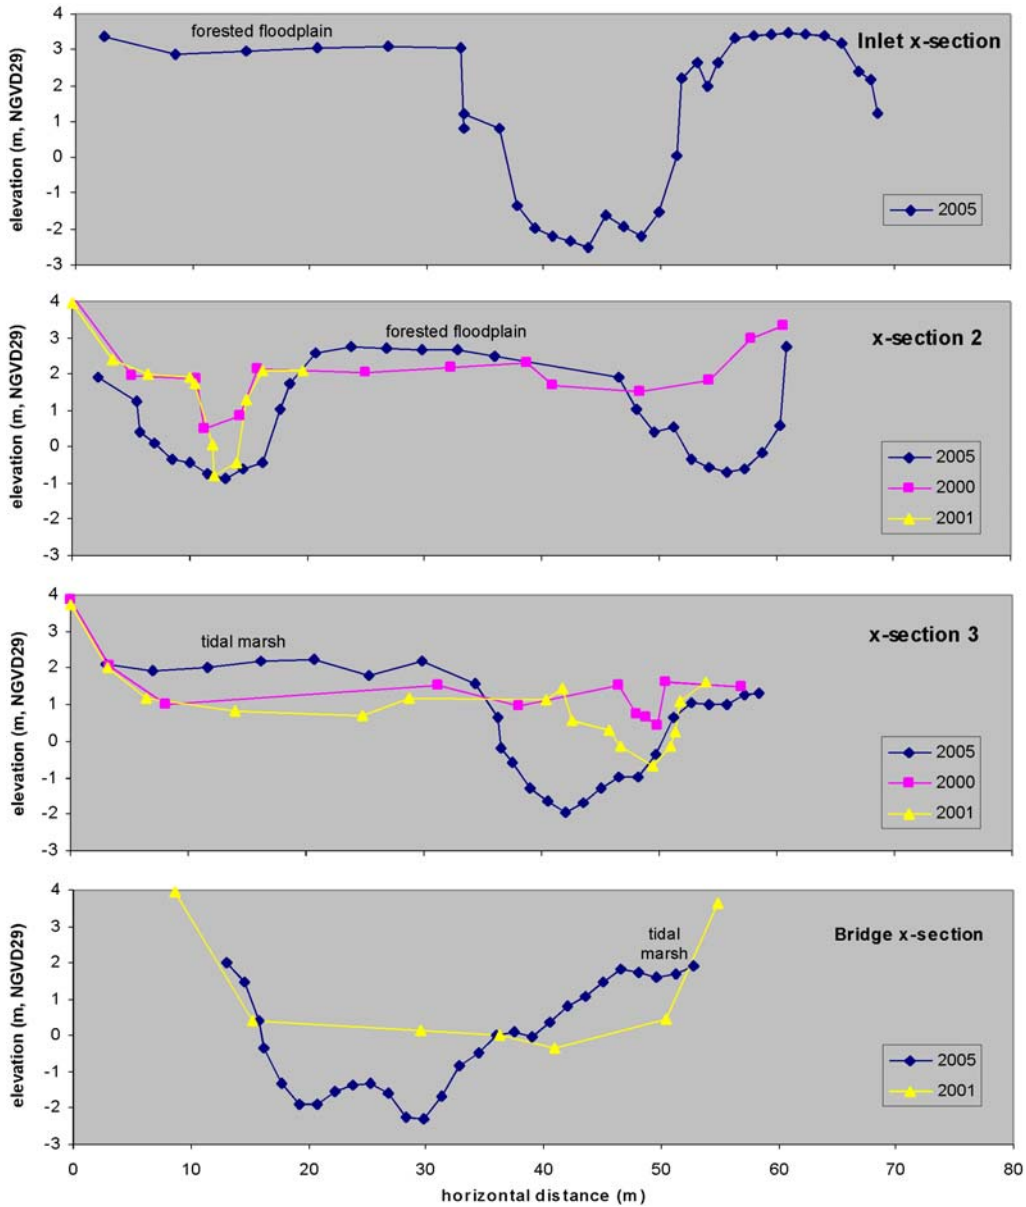
An entirely new cross-section transect was established near the upstream mouth (inlet) of Deepwater Slough (Fig. 3), so no comparisons with previous transects can be made. This transect was established to document future changes in channel form in this area. Cross-section 2 shows the expected channel development from 2000 to 2001 and the dramatic development of an avulsed side-channel (caused by the October 2003 flood) by 2005. Ground surface elevation has declined by about ½ meter on the left bank and increased by about ½ meter on the right, in an area that is now an island. The left bank erosion is consistent with even greater erosion immediately upstream in 2001 that threatened the adjacent dike and resulted in WDFW installing rip-rap (visible in 2002 and 2004 photos, see Fig. 2). The increased elevation in the area that is now an island is likely due to sediment deposition during floods. This pattern is consistent with the transect location in a slight meander bend. The left bank is a cut bank and the current island is a depositional point bar that has been cut off on its back side by the 2003 channel avulsion. Hardening of the left bank, or cut bank, with rip-rap probably led to the channel avulsion. Flood energy that would otherwise have been dissipated by enlarging the channel meander was instead redirected toward the avulsion.

Cross-section 3 shows a steady increase in channel cross-section area as expected. There is also a decrease in marsh surface elevation of approximately ¾ meter on the right bank of the channel over a width of 5m, and a 1m increase in marsh surface elevation on the left bank over a width of about 25m. Field observations indicate that the left bank has received extensive deposits of sand that during 2001-2002 smothered cattails and which now is being colonized by willows (*Salix* spp.) and sweetgale (*Myrica gale*). The marsh surface erosion and deposition patterns are consistent with the slight channel meander present in this area.

Cross-section 4 is located where the upstream dike used to be and where a bridge is currently located. No channel was present in 2000, so there is no transect for that year. The 2001 transect represents a broad unchannelized plain that remained when the dike was removed. The 2005 transect shows a clearly developed channel. Incidentally, the aerial photos show a clear channel in 2002, comparable to the channel in 2004.

Figure 3. Channel cross-sections for transects 1-4. View is directed downstream.

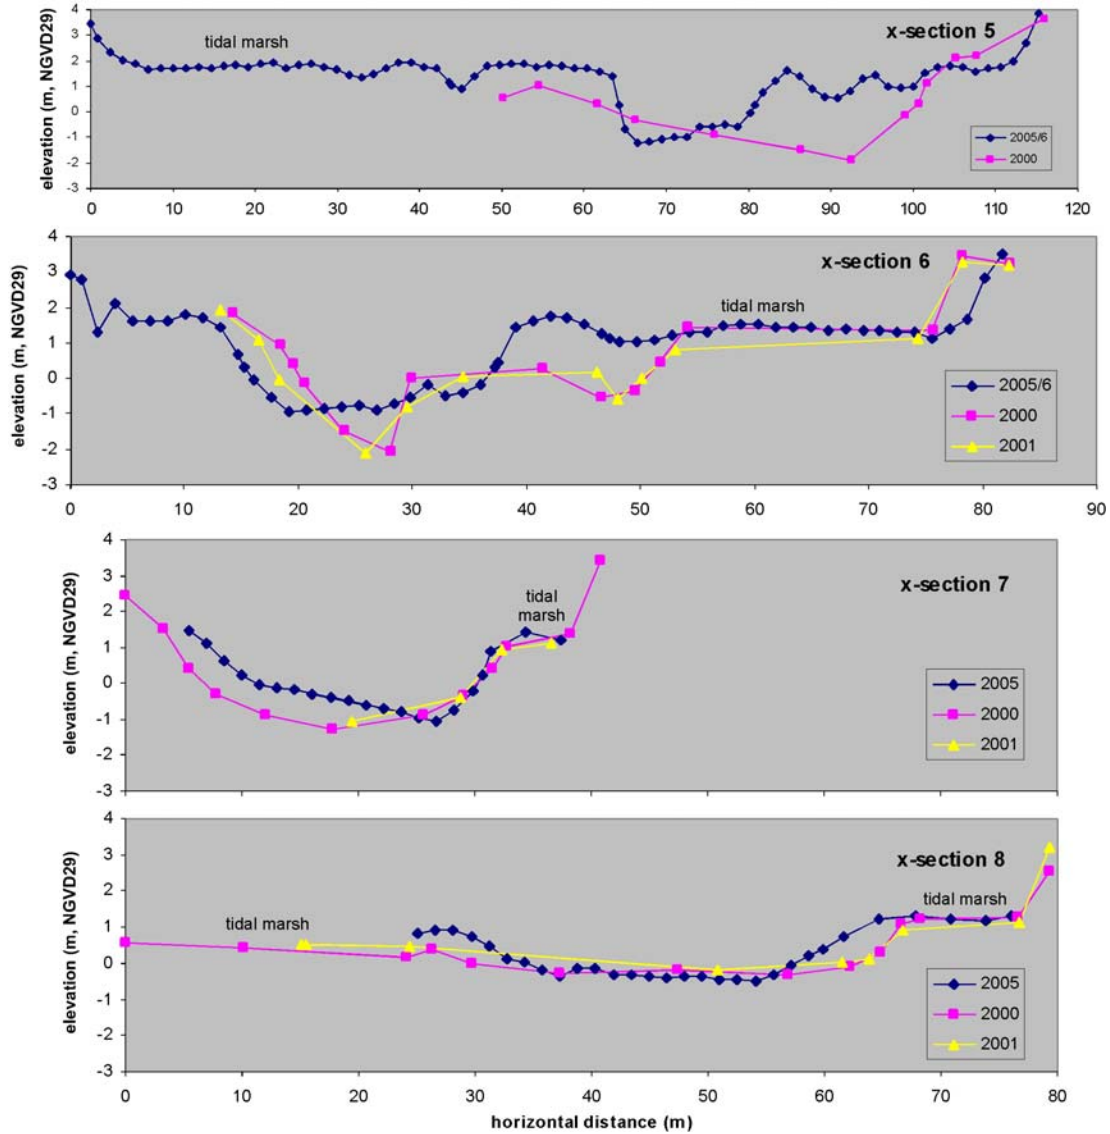
Cross-section 5 is located just downstream of the bridge and is an area that has been accumulating sediments in the channel, particularly on the right bank (looking downstream) (Fig. 4). The cross-sectional information combined with the planform photos suggest that dike removal was followed by vegetation destruction on the right bank particularly, likely due to the combined stresses of increased inundation and burial by sediments. These accumulated sediments appear in the 2004 photo as gray sands.

Cross-section 6 is located on a channel bend and shows some bank erosion high on the right (cut) bank, while a natural flood levee appears to be forming lower on the marsh adjacent to the right channel bank.

Cross-section 7 is located in the relatively stable (from a planform perspective) channel reach downstream of the bridge. However, the channel is shoaling by about ¾ meter over most of the cross-section.

Cross-section 8 is located in a reach where the channel blends into tidal marsh on its left bank. However, in recent years this cross-section appears to be developing a natural flood levee on its left bank (about ½ meter higher than previously) and depositing

sediment on the right bank. The development of this natural levee is an additional indication that natural flood processes have been restored to this channel reach.

Figure 4. Channel cross-sections for transects 5-8. View is directed downstream. Note, the x and y scales of transect 5 is 70% of that of the other transects.

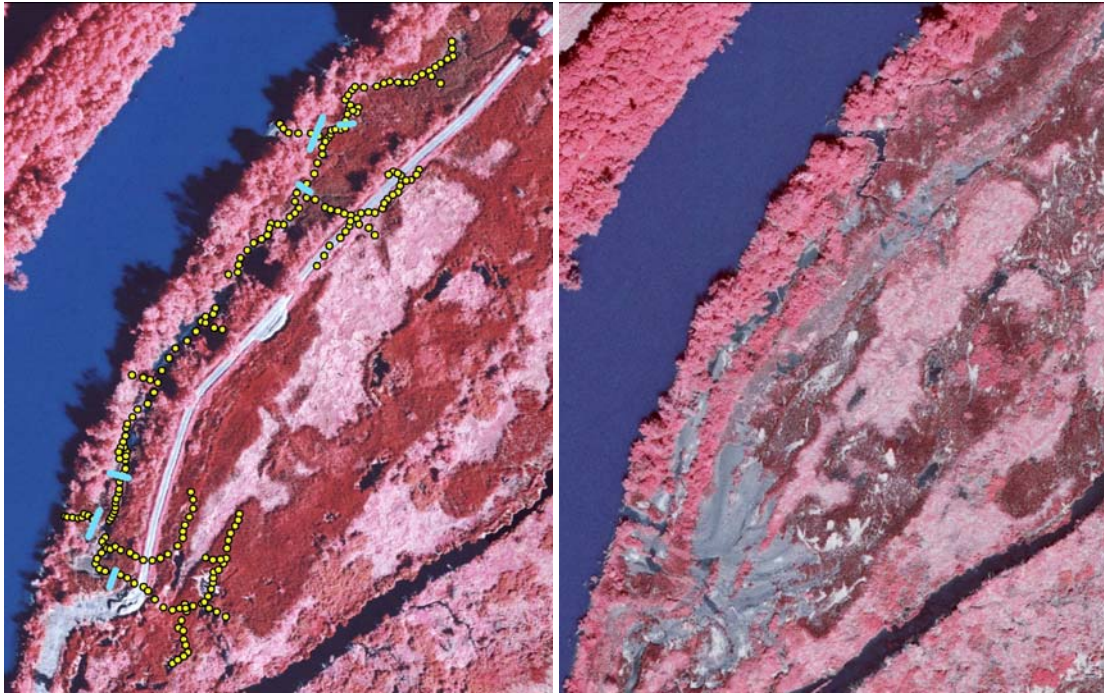
The two largest protochannels developing on the restoration site were mapped along their centerline with GPS to groundtruth aerial photo interpretation. Channel cross-sections were also surveyed in several locations (Fig. 5). Protochannels are channels that were unplanned and unforeseen during site restoration. These channels are cutting across the former dike footprint as a result of natural tidal processes, without any encouragement from artificial channel excavation. The two largest channels are actually extensions of pre-existing channels that were located outside of, and immediately adjacent to, the original dikes (now removed). Their channel branches now clearly extend beyond the dike footprint, more so for the southern protochannel than the northern one. This result suggests some predictability. Pre-existing external tidal channels are perhaps likely to extend through headward erosion into a restoration site if no dikes impede their potential. This is the logical result of restoring significant tidal prism to their locality. Thus, at a minimum, dike breaches should be located near any and all external tidal channels that might be present, regardless of their size. Even small channel may become significantly larger given increased tidal prism.

Figure 5. Current (2005/6) channel courses (yellow GPS points) of the two largest protochannels developing on the restoration site. Surveyed cross-sections (2005/6) are shown as light blue lines. The background photo is from 2000 and shows the dike in the process of being removed. The photo to the right is 2002 and shows a sediment splay in the lower left corner (gray sands) delivered by a 5-yr flood event.

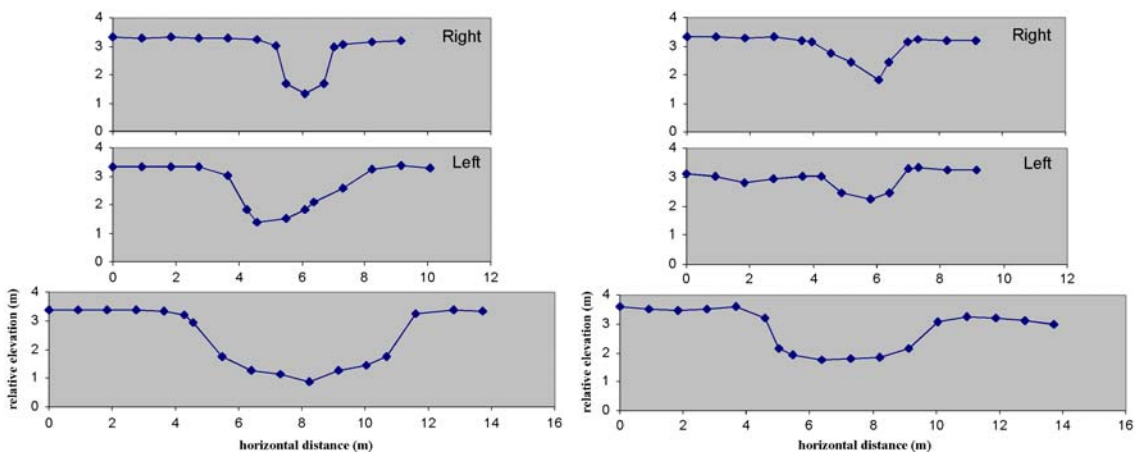
Channel cross-sections were measured near the mouths (outlets) of the two protochannels and across each of two major forks in each protochannel (Fig. 6). These cross-sections were measured for the first time this year and will serve as comparisons for future cross-section surveys to monitor channel growth. Comparisons of the pre-restoration photo of 2000, later photos and the field surveys, indicate channel width of the northern outlet appears to have increased from approximately 1.5 m (2000 photo) to 5.2 m (2002 photo) and 4.7 m (2004 photo) to 7.3 m (2005/6 survey), while the right fork (which extends into the restoration site) cross-section width appears to have increased from approximately 1 m (2000 photo) to 2.6 m (2002 photo) and declined back to 1.7 m (2004 photo) and 1.8 m (2005/6 survey). The left fork is indistinct in the photos due to significant plant cover, so photo-based measures of channel width are unreliable. Similar comparisons for the southern protochannel indicate that its outlet width grew from 0.7 m

(2000 photo) to 3.5 m (2002 photo), 3.0 m (2004 photo), and 5.5 m (2005/6 survey). The right fork, which crosses the dike footprint into the restored marsh, appeared to be 0.5 m wide in the 2000-2002-2004 photos, but field surveys indicate it was 3.0 m wide in 2005/6. The left fork, which remains outside the dike footprint grew slightly from 1.8 m in 2000 and 2002 to 2.7 m in the field surveys of 2005/6. The 2004 photo had too much vegetation coverage to distinguish channel banks clearly.

Figure 6. Channel cross-sections of protochannels depicted in Figure 5. Cross-sections on the left are those of the northern protochannel, those on the right are of the southern protochannel. Left and right channel forks are from the perspective of viewing the channel upstream from the mouth.

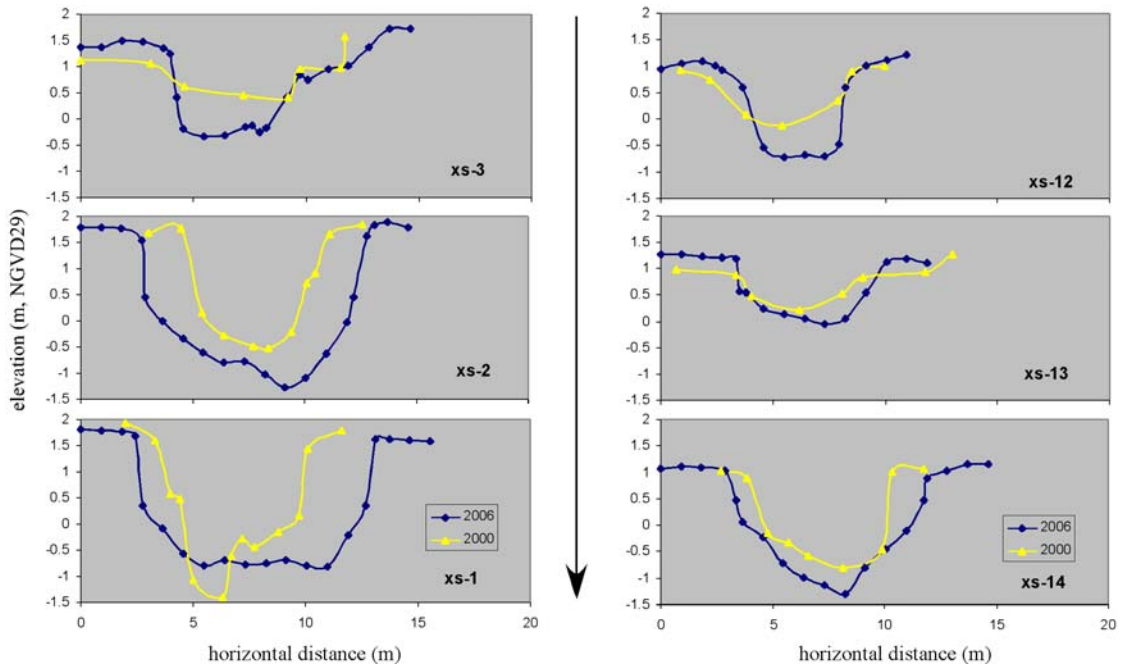
Figure 9. Channel cross-sections at or near channel outlets for two restored blind channel networks. The arrow shows ebb-tide flow direction. See Figure 8 for cross-section locations. Blue = 2006, yellow = 2000.

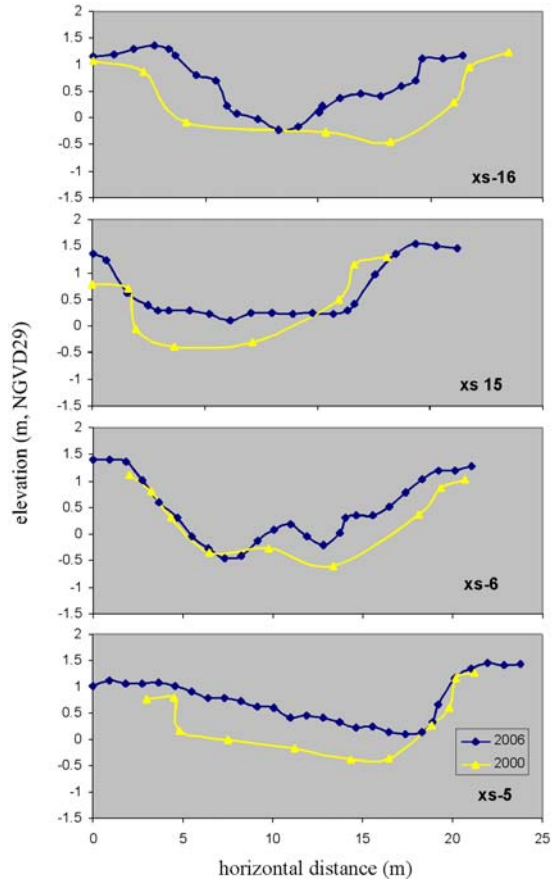
Figure 10. Mid-channel cross-sections, showing considerable sedimentation between 2000 (yellow) and 2006 (blue). See Figure 8 for cross-section locations. The arrow indicates ebb-tide flow direction for the channel cross-section sequence.

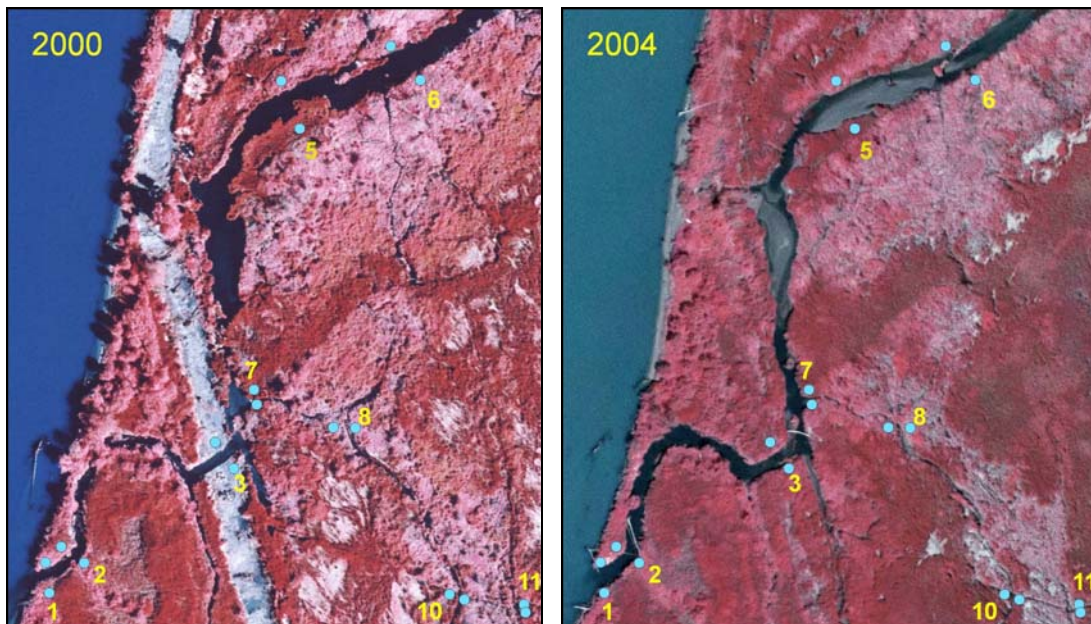
Figure 11. Detail of blind tidal channel which was reconnected to tidal influence. End-points of cross-sections are denoted by light blue dots and yellow numbers. Note obvious sediment accumulation in the channel at cross-sections 5 and 6, and between sections 3 and 5. Sediment has also accumulated at sections 7 and 8, but not at 10 and 11. This is probably due to the proximity of sections 7 and 8 to a sediment source, i.e., the lower reach of a large tidal channel to which they are directly connected.

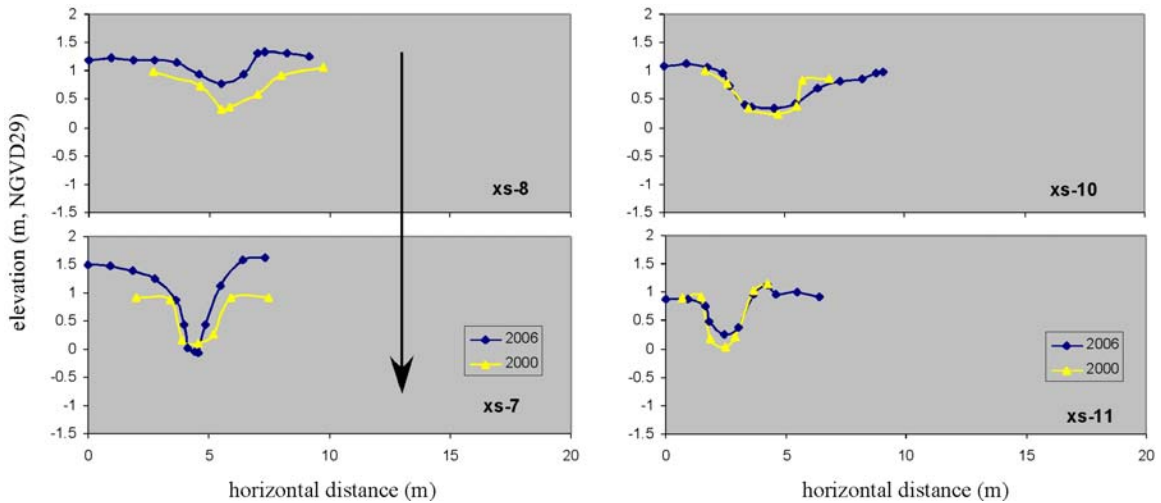
Figure 11. Headward channel cross-sections, showing considerable sedimentation between 2000 (yellow) and 2006 (blue) for two cross-sections close to a sediment source (left) and relative stability for small channels far from sediment sources (right). See Figure 8 for cross-section locations. The arrow indicates ebb-tide flow direction for the channel cross-section sequence xs-8 and xs-7. The other two channels cross-sections are not sequentially associated.
