# Deepwater Slough Restoration Monitoring: Channel Cross-section Comparisons, 2000 - 2006

W. Gregory Hood  
Skagit River System Cooperative  
LaConner, Washington

10 May 2006

Prepared for US Army Corps of Engineers, Seattle District

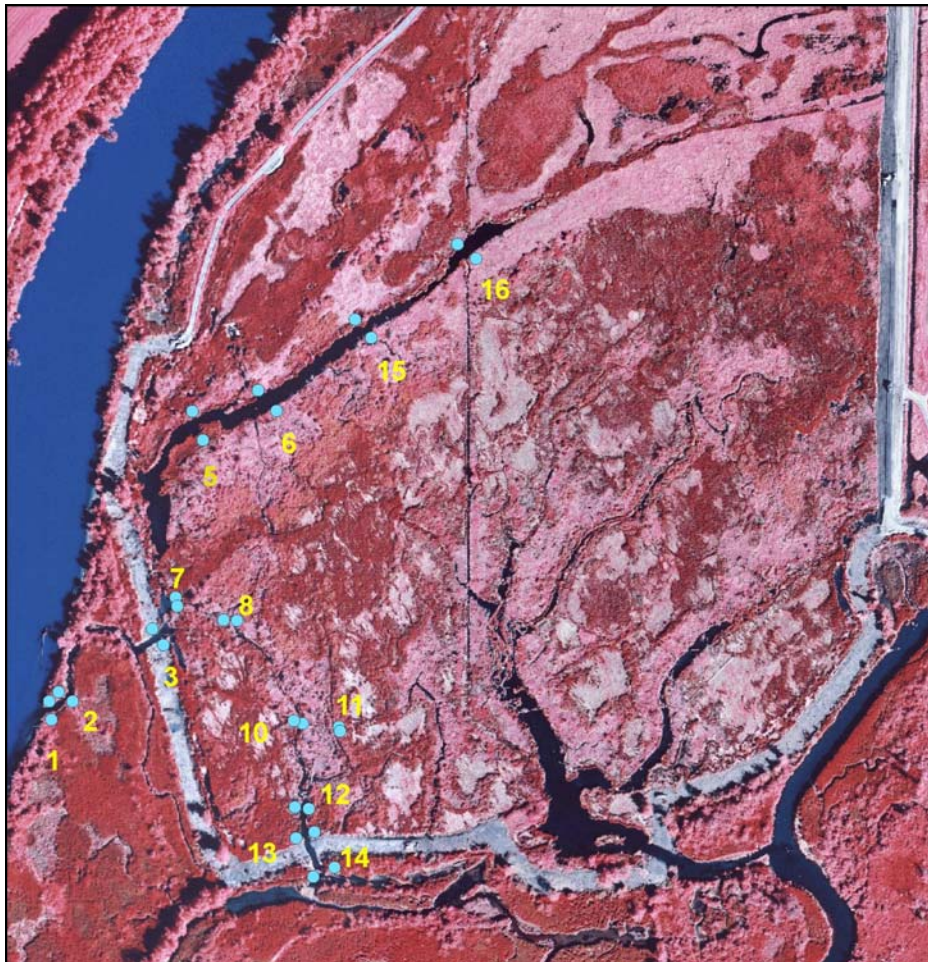
Figure 7. Location of channel cross-section comparisons between 2000 and 2006. End-points of cross-sections are denoted by light blue dots and yellow numbers. Cross-sections 4 and 9 are not shown because their 2006 locations were sufficiently misaligned with the 2000 locations to make comparison questionable. Dike footprint = blue-gray stripe (e.g., between x-sections 13 and 14, and at x-section 3). Note x-sections 1, 2, and 14 are located outside of the restoration site. Photo is from summer of 2000.

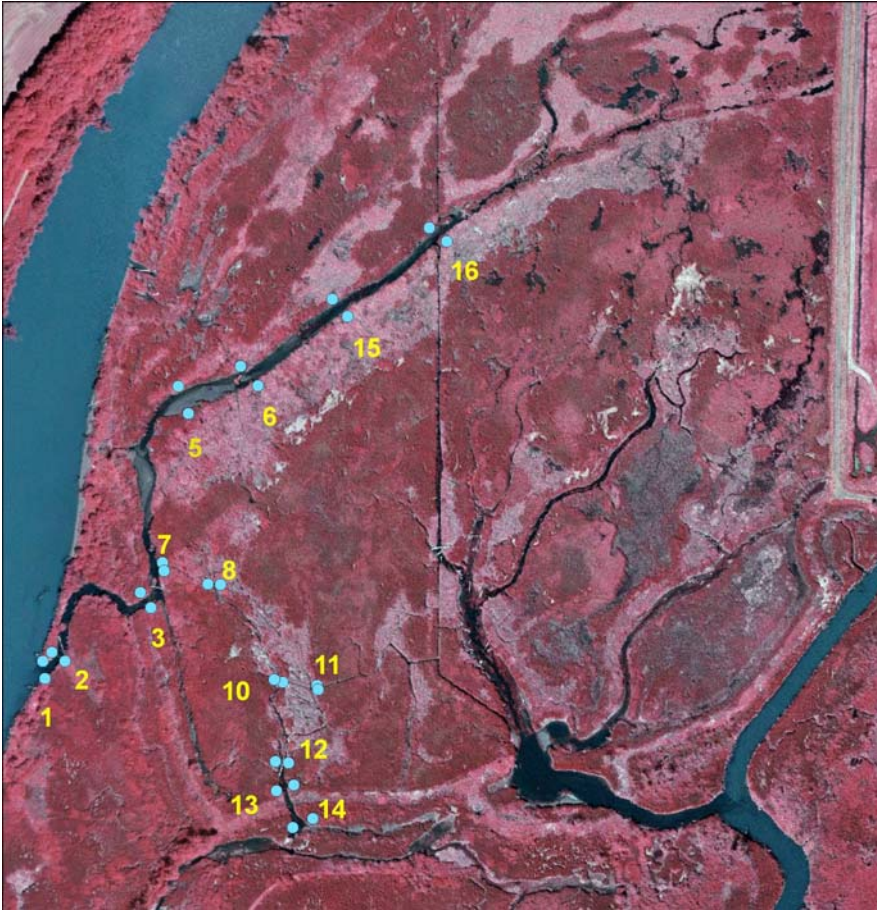
Figure 8. Location of channel cross-section comparisons between 2000 and 2006. End-points of cross-sections are denoted by light blue dots and yellow numbers. Cross-sections 4 and 9 are not shown because their 2006 locations were sufficiently misaligned with the 2000 locations to make comparison questionable. Note x-sections 1, 2, and 14 are located outside of the restoration site. Photo is from summer of 2004.
